TECHNICAL INSPECTION REPORT

U.S.S DENTUDA (SS335)

TEST ABLE

OPERATION CROSSROADS

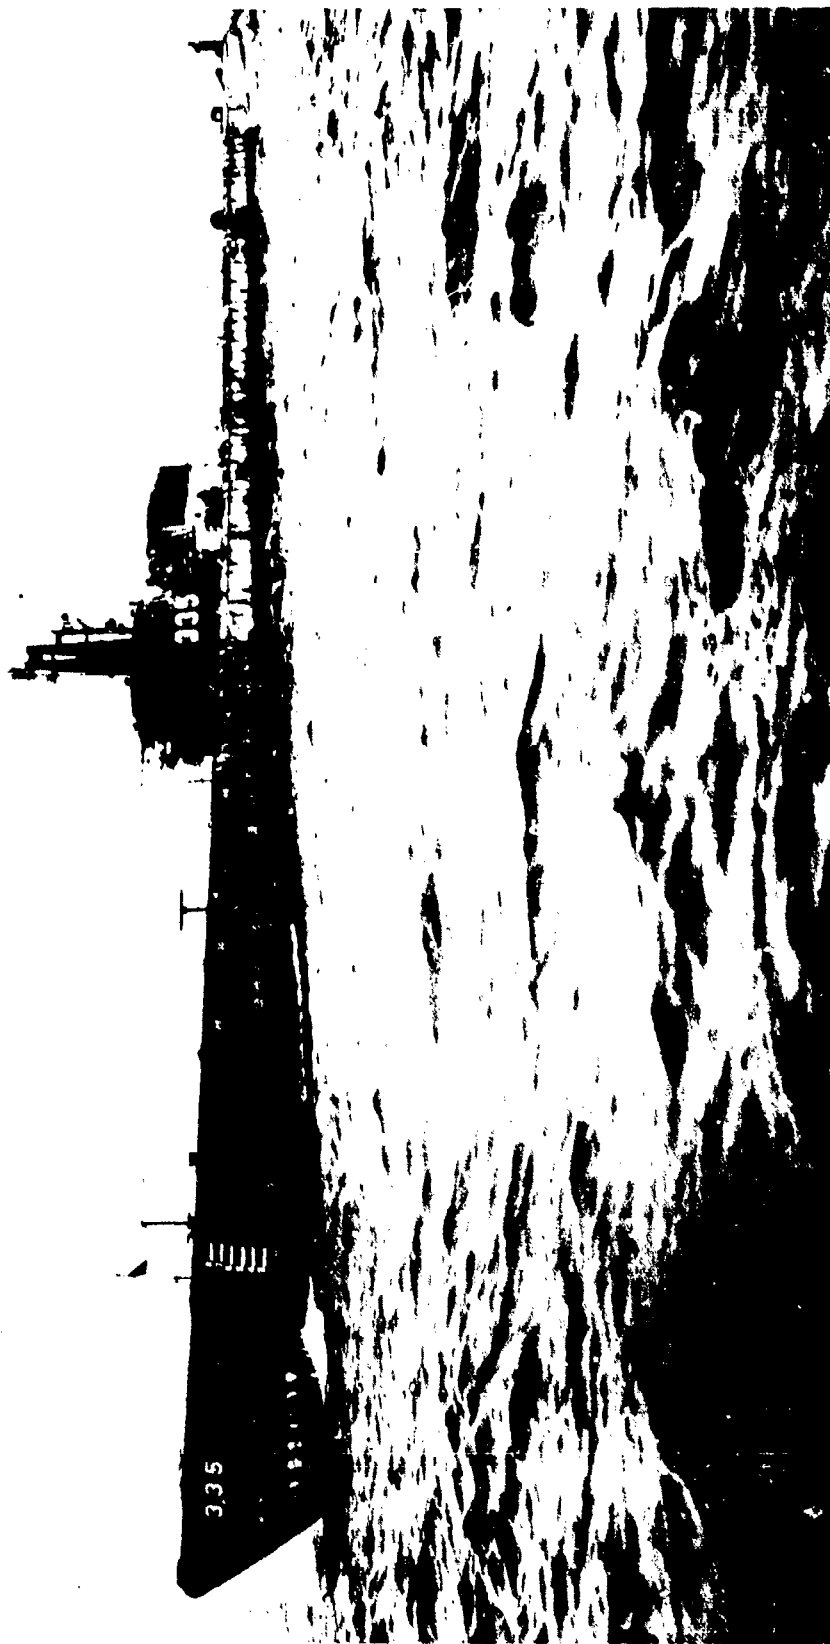
There is a very slight scorching of the outer coat of paint on the vertical surfaces of the starboard side of the superstructure and conning tower fairwater. No scorching was noted on horizontal surfaces or where the vertical surfaces were shielded by other structures. The heat flash appears to have come from approximately 110° relative. There were no apparent reflections of heat wave back onto a surface which did not face the blast. The scorching is more severe near the top of the periscope shears than lower on the conning tower fairwater.

AACR-227-92-31. General view from starboard bow.
